Home Inspection Report

123 Insight Sample Report Lane, Knoxville, TN 37922

Friday July 14, 2017

071417-1

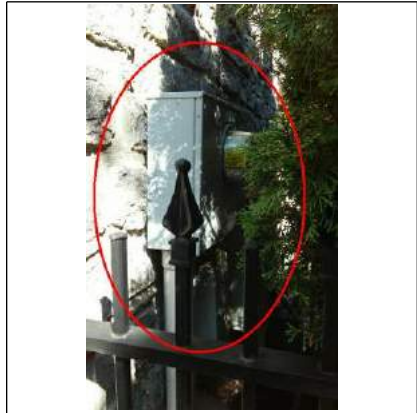
Service entry at left side facing.

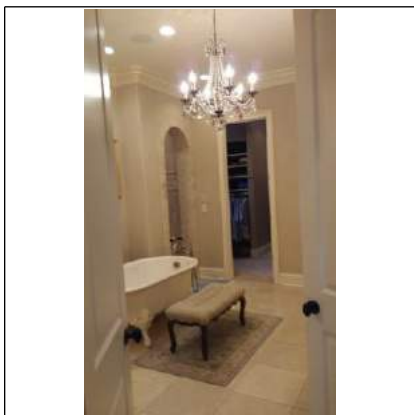
Bathroom (2)

Comments Closet door needs adjustment to latch.

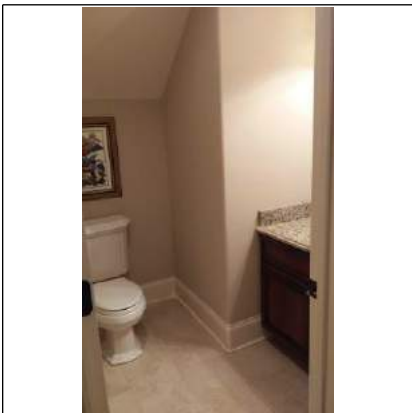
Bathroom (4)

Comments Toilet bowl is loose recommend repair.

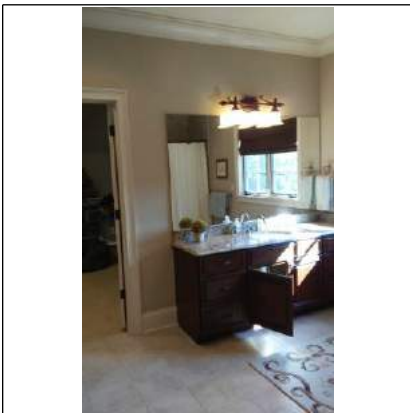
Bathroom (6)

- Heat source present** Yes No
- Exhaust fan** Yes No Operable: Yes No Noisy
- Comments** Toilet bowl is loose recommend repair.

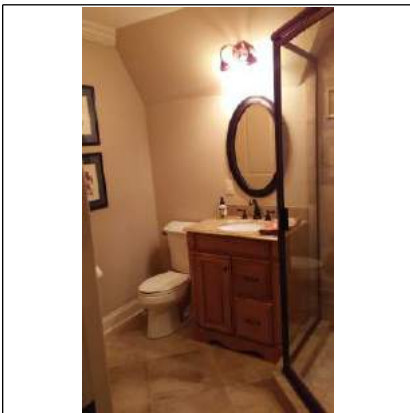
Bathroom (7)

Comments Door needs adjustment to latch.

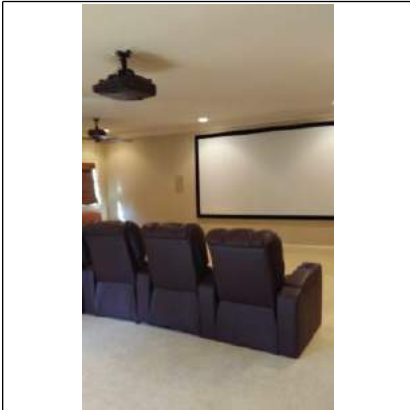
Room (7)

Comments Door to 3rd floor needs adjustment to latch.

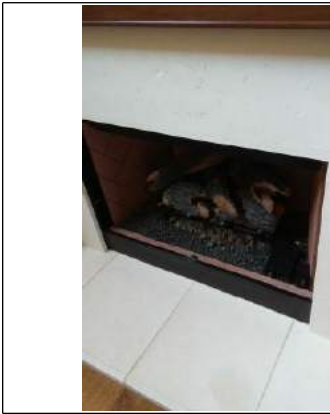
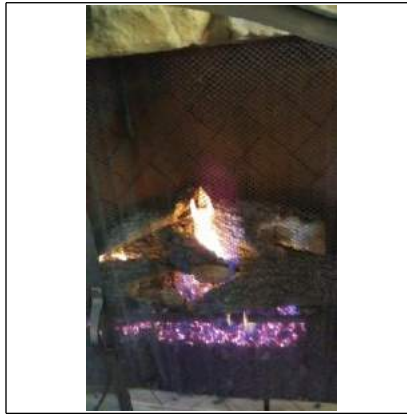
Fireplace

Comments Recommend modifying damper for gas use.

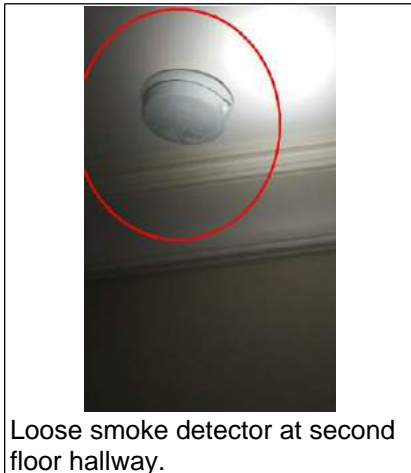
Loose smoke detector at second floor hallway.

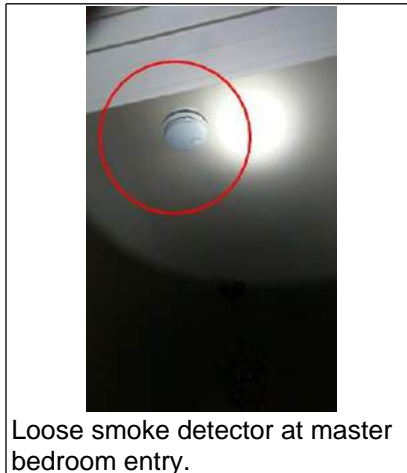
Loose smoke detector at master bedroom entry.

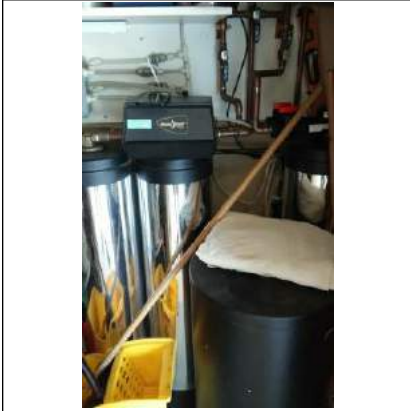
Water softener located in the garage closet.

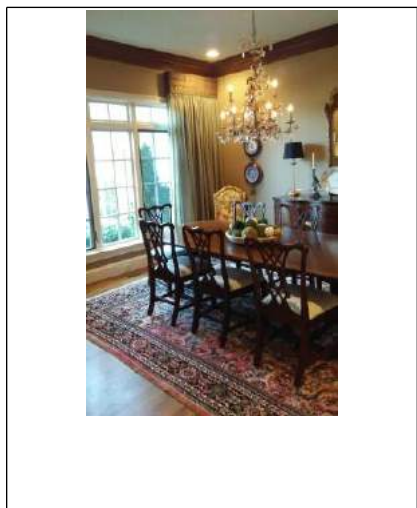
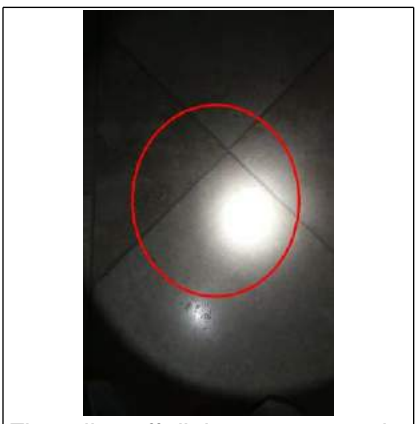
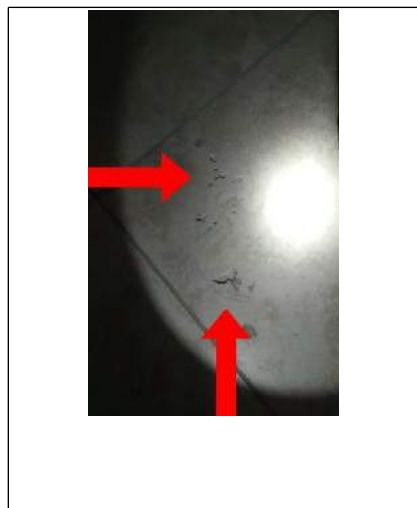
Floor tiles off dining room at main entry show some damage, example pics below.
